REFURBISHMENT SIKA SOLUTIONS FOR SEWERS AND WASTE WATER TREATMENT PLANTS

SIKA SOLUTIONS FOR SEWERS

PROBLEMS AND DAMAGES TO STRUCTURES

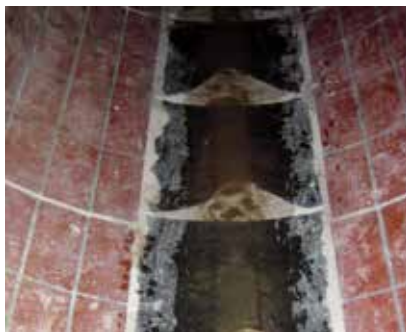
1 Damages at the bottom:

Heavy abrasion and erosion of the concrete and prefabricated elements are often found at the bottom of the sewers. In general rules, these elements shall be replaced and reassembled properly by bonding them in place with an epoxy adhesive. In case of concrete substrate, the erosion can be repaired with a high abrasion resistant mortar that will increase the service life of the substrate

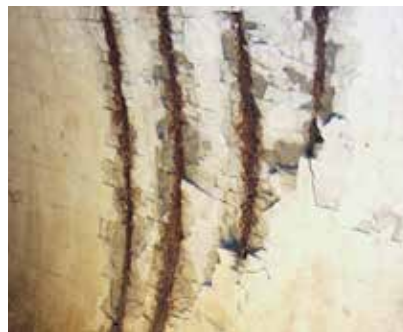
2 Localized defects of the concrete:

Lateral walls and the crown often show localized defects of the concrete and sometimes defects due to the corrosion of the reinforcement. After appropriate preparation, these defects can be repaired using sulfate resistant repair mortars.

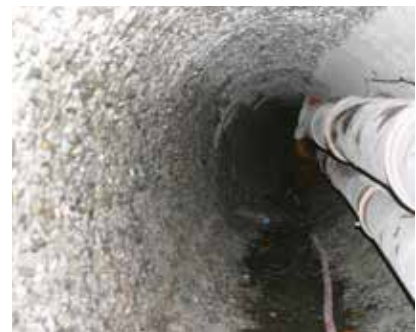
3 Full degradation of the concrete surface:

The resistance of tamped concrete against a strong water current is generally not enough and often the full surface of the concrete is eroded. It is recommended in these zones to proceed with a full resurfacing.

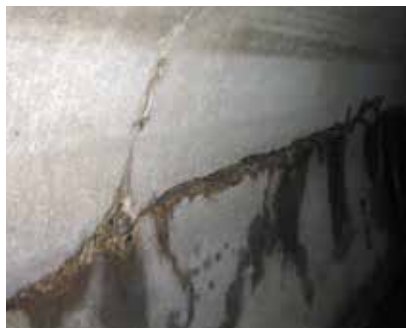
4 Cracks with water leaks:

Due to shrinkage or settlements, concrete in sewers often cracks. These cracks need to be filled in order to prevent leakage of pollutant to surrounding ground water. It is often necessary to use expanding materials to fill these cracks.

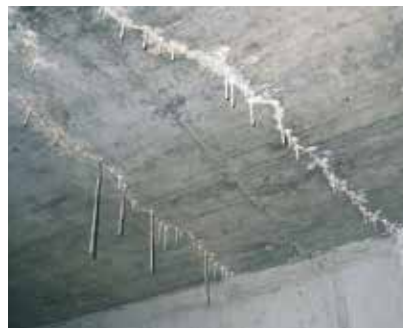
5 Damages at the crown:

Exposed tamped concrete surfaces show very low resistance against carbonation and the aggressive substances contained in the waste water. Therefore, these surfaces can be protected using EpoCem® technologies which are extremely resistant and watertight against urban waste water.

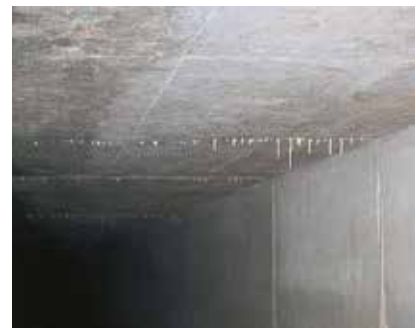
At the crown area, the structure can be protected against condensation water using a hydrophobic impregnation.

Additionally, the aerial part of the sewer can suffer from biogenic corrosion or microbial induced corrosion (MIC). To repair and protect these areas a 100% Calcium Aluminate Mortar must be used.

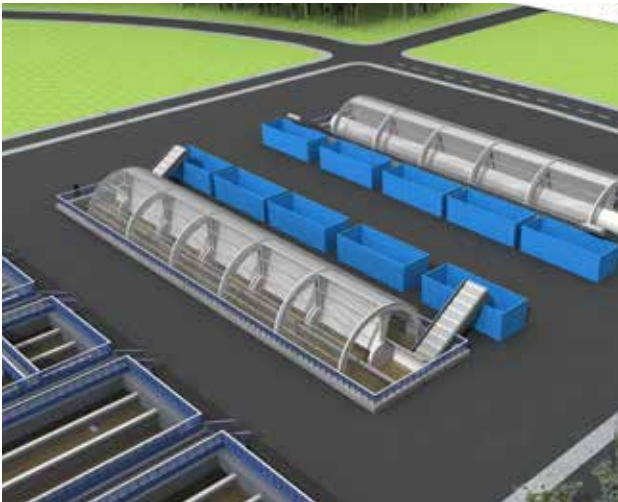
SCREENING CHANNELS

- Abrasion and erosion due to sand, grit or other heavy particles
- Chemical attacks due to aggressive waste or industrial water
- Leakage due to cracks, untight joints or damaged concrete
- Biogenic corrosion in covered channels due to the action of bacteria contained in the sewage

- Abrasion and erosion:
Sika MonoTop®-3400 Abraroc
- Chemical attacks:
Sikagard®-720 EpoCem® + Sikagard®-63 N/-62,
SikaCor®-950 F
- Cracks, untight joints:
Sikadur-Combiflex® SG, Sika® Injection-451 or
Sikaflex® PRO-3
- Microbial induced corrosion (MIC) in covered areas:
Sika MonoTop®-4400 MIC

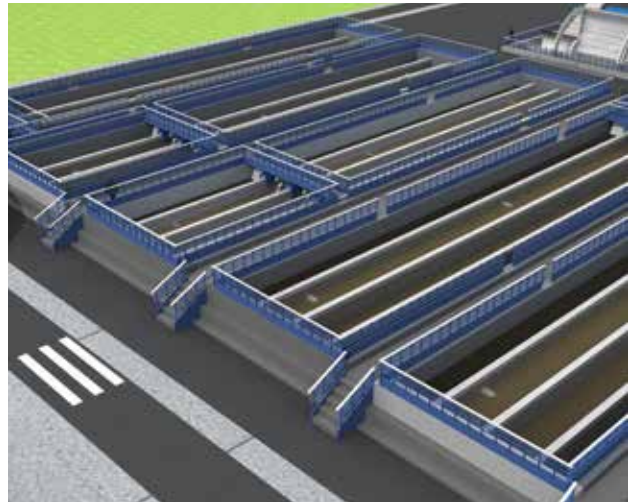
GRIT, FAT & GREASE CHAMBERS

- Abrasion and erosion due to sand, grit or other heavy particles
- Chemical attacks due to aggressive waste or industrial water
- Leakage due to cracks, untight joints or damaged concrete
- Biogenic corrosion in covered channels due to the action of bacteria contained in the sewage

- Abrasion and erosion:
Sika MonoTop®-3400 Abraroc
- Chemical attacks:
Sikagard®-720 EpoCem® + Sikagard®-63 N/-62,
SikaCor®-950 F
- Cracks, untight joints:
Sikadur-Combiflex® SG, Sika® Injection-451 or
Sikaflex® PRO-3
- Microbial induced corrosion (MIC) in covered areas:
Sika MonoTop®-4400 MIC

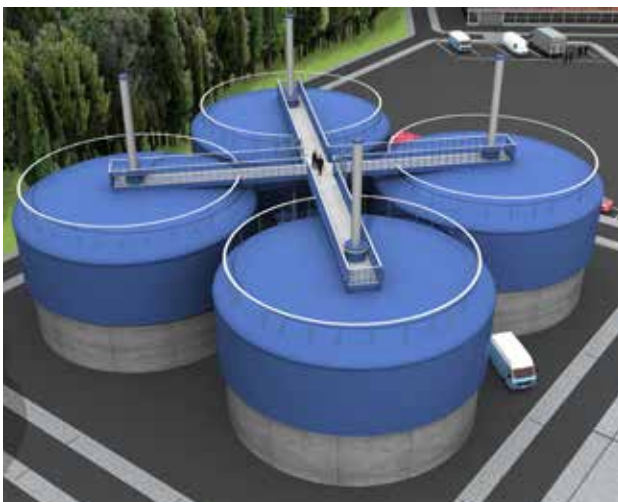
GASOMETERS

- Steel corrosion
- Untight joints
- Sulfuric acid damages

- Steel corrosion:
Sika® Icosit® 6630 System or SikaCor® EG System
- Steel joint:
Sikaflex® TS Plus
- Sulfuric acid attack:
Sika® Permacor® 3326 EG H or Sikalastic®-8440

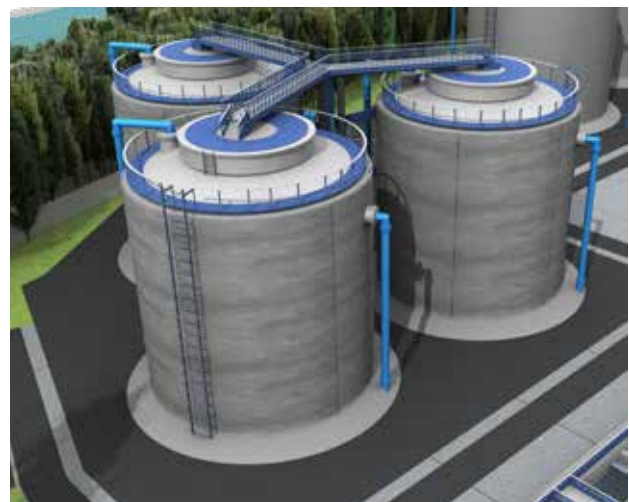
DIGESTION TANKS

- Concrete damage due to sulfuric acid
- Leakage due to damaged waterproofing
- Cracks due to thermal expansion or shrinkage

- Sulfuric acid attack and waterproofing:
Sika® Permacor® 3326 EG H or Sikalastic®-8440
- Cracks:
Sikadur-Combiflex® SG or Sika® Injection-451
- Chemical resistant joint:
Sikaflex® TS Plus

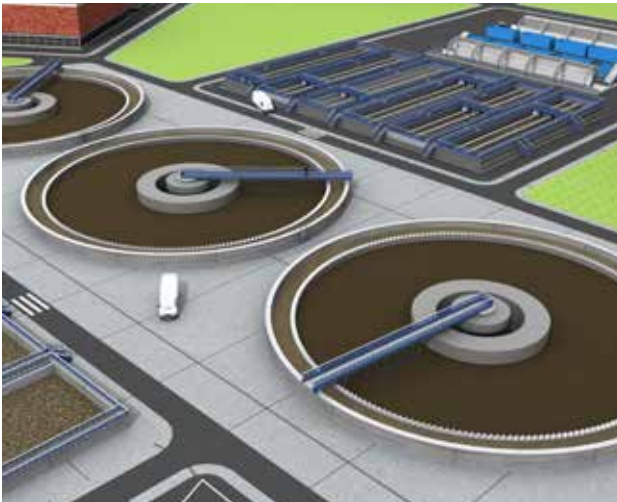
PRIMARY SEDIMENTATION TANKS

- Chemical attacks due to aggressive waste or industrial water
- Leakage due to improper waterproofing
- Cracks due to thermal expansion or shrinkage
- Steel reinforcement corrosion due to low concrete cover
- Mechanical abrasion at the rolling pad

- Chemical attacks and damaged waterproofing: Sikagard®-720 EpoCem® + Sikagard®-63 N/-62, SikaCor®-950 F
- Cracks, untight joints: Sikadur-Combiflex® SG, Sika® Injection-451 or Sikaflex® PRO-3
- Damaged concrete and steel reinforcement corrosion: Sika MonoTop®-412 NFG, SikaTop® Armatec®-110 EpoCem®, Sika MonoTop®-2400 Reseaux
- Mechanical abrasion: Sikadur®-42 or Sika® Icosit®-KC 330 FK

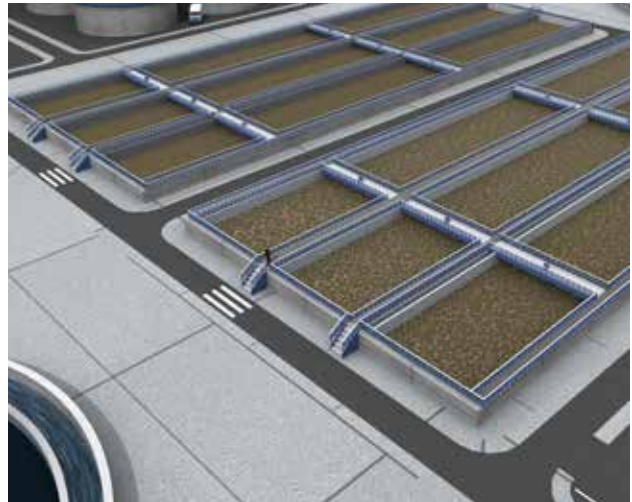
BIOLOGICAL TANKS

- Erosion due to water flow
- Chemical attacks due to aggressive waste or industrial water
- Leakage due to damaged waterproofing
- Cracks due to thermal expansion or shrinkage
- Steel reinforcement corrosion due to low concrete cover

- Chemical attacks and damaged waterproofing: Sikagard®-720 EpoCem® + Sikagard®-63 N/-62, SikaCor®-950 F
- Cracks, untight joints: Sikadur-Combiflex® SG, Sika® Injection-451 or Sikaflex® PRO-3
- Damaged concrete and steel reinforcement corrosion: Sika MonoTop®-412 NFG, SikaTop® Armatec®-110 EpoCem®, Sika MonoTop®-2400 Reseaux

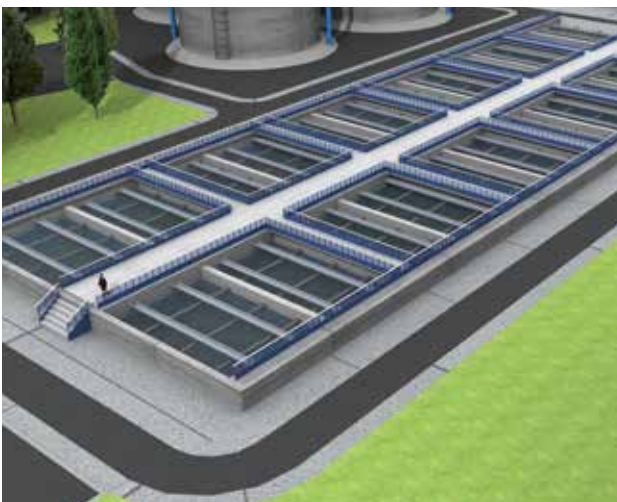
FILTRATION BEDS

- Abrasion due to sand
- Leakage due to damaged waterproofing
- Cracks due to thermal expansion or shrinkage

- Abrasion: Sika MonoTop®-3400 Abraroc
- Damaged waterproofing: Sikagard®-720 EpoCem®
- Cracks: Sikadur-Combiflex® SG or Sikaflex® PRO-3

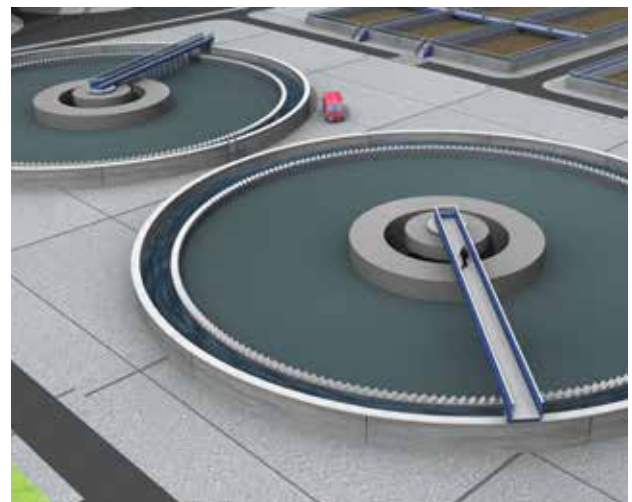
SECONDARY SEDIMENTATION TANKS

- Leakage due to damaged waterproofing
- Cracks due to thermal expansion or shrinkage
- Mechanical abrasion at the rolling pad

- Damaged waterproofing: Sikagard®-720 EpoCem®
- Cracks: Sikadur-Combiflex® SG or Sikaflex® PRO-3

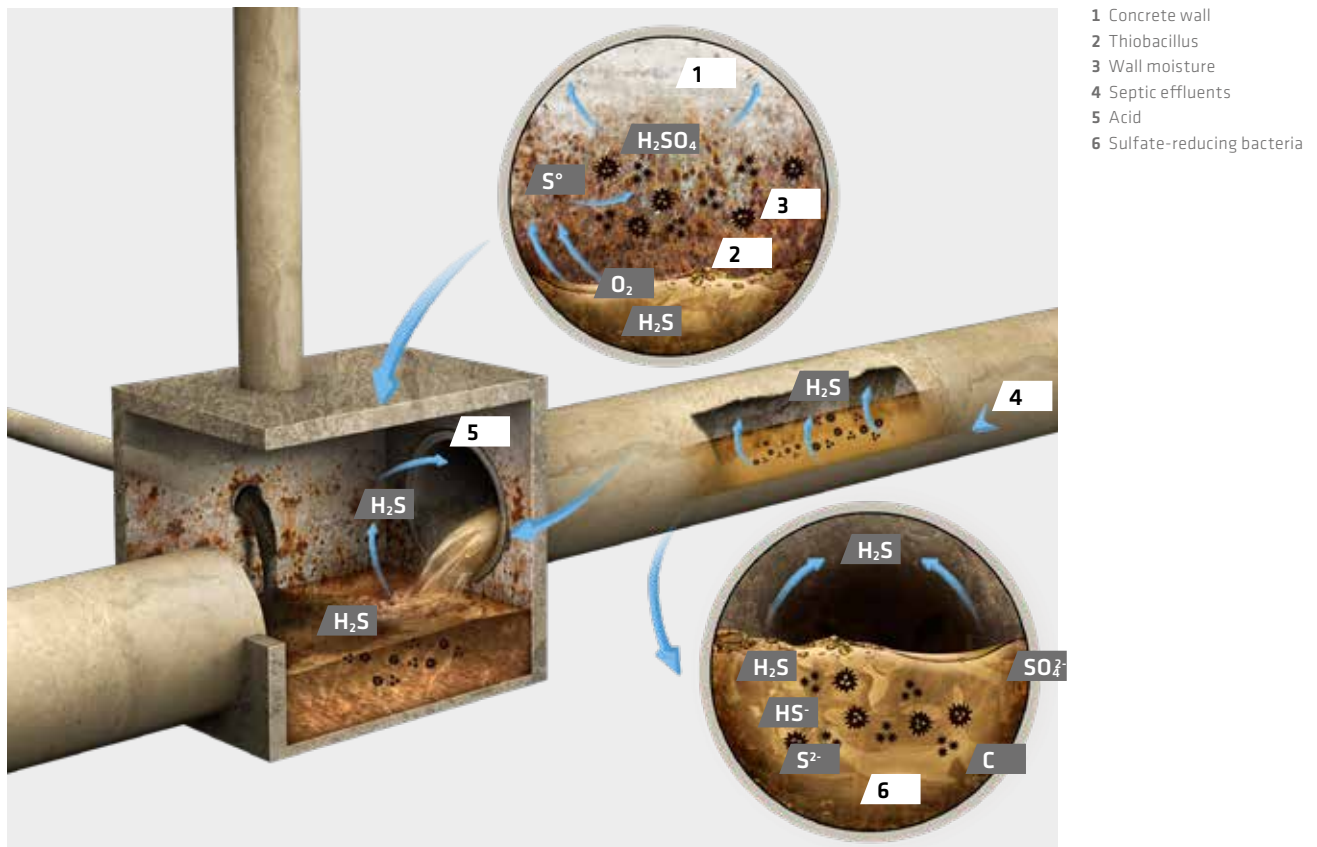
MICROBIAL INDUCED CORROSION PRINCIPLES

Microbial induced corrosion happens when sulphates in biological waste are converted into sulphides through a bio-

logical process under the anaerobic conditions below the waste-water line in the sewers. Above the waste-water line, the hydrogen sulphide gas that is released in this process forms aggressive and corrosive condensates with water such as sulfurous and then sulphuric acid.

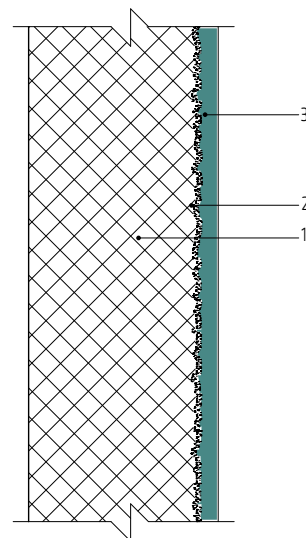
- 1 Host concrete
- 2 Abraded surface
- 3 Over laying with
Sika MonoTop®-3400 Abraroc

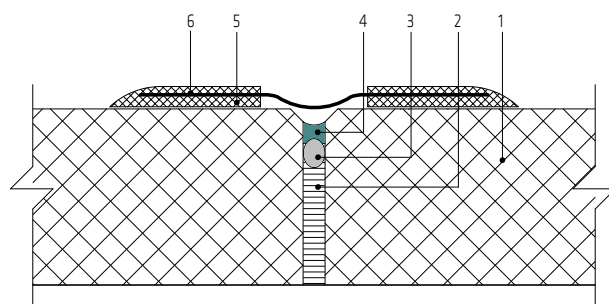
TYPICAL DETAIL

- 1 Substrate
- 2 Existing compression profile
- 3 Existing backing rod
- 4 Failed sealant
- 5 Sikadur® adhesive
- 6 Sikadur-Combiflex® SG Tape

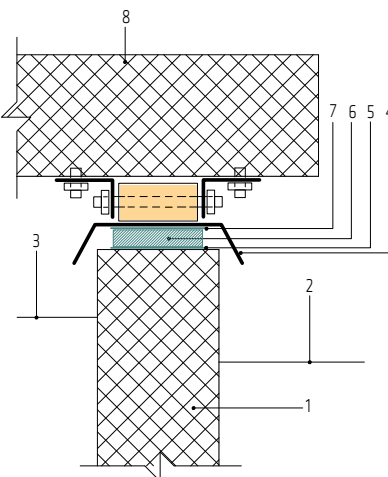
TYPICAL DETAIL

- 1 Concrete wall of clarifier
- 2 Ground level
- 3 Water level within the clarifier
- 4 V2A Stainless steel plate
- 5 Priming of concrete surface with Primer such as Sika® Icosit® KC 330 Primer or equivalent
- 6 Shock absorbing, vibration damping & bonding material such as Sika® Icosit® KC 330 FK
- 7 Priming after grinding the under side of the stainless steel plate with primer such as Sika® Icosit® KC Primer or equivalent
- 8 Scraper bridge

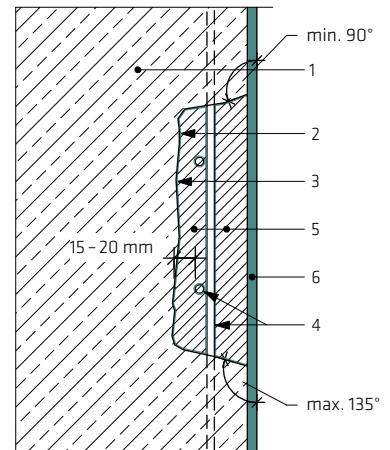
TYPICAL DETAIL

- 1 Host sound concrete
- 2 Cutting line of damaged concrete, cleaned and prepared substrate
- 3 Bonding primer (if relevant/required: e.g. SikaTop® Armatec®-110 EpoCem®)
- 4 Corrosion protective coat (e.g. SikaTop® Armatec®-110 EpoCem®)
- 5 Repair mortar (e.g. Sika MonoTop®-412 NFG)
- 6 Smoothing coat (e.g. Sika MonoTop®-3012/-723 Eco)

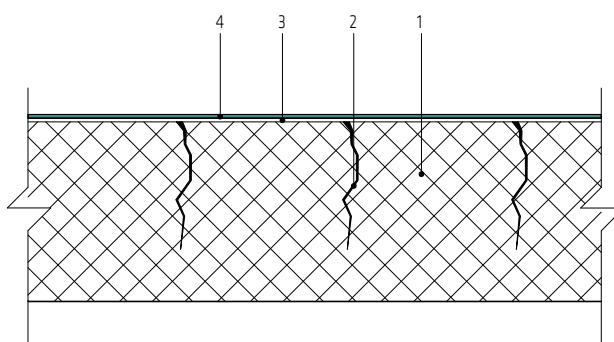
TYPICAL DETAIL

1 Concrete

2 Cracks

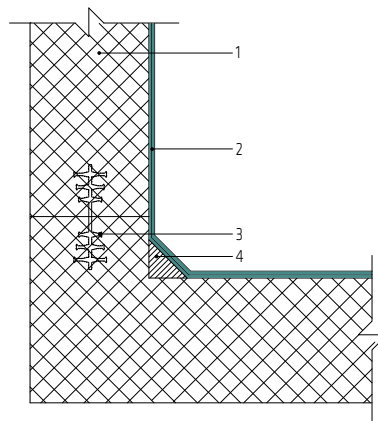
- 1 Concrete substrate
- 2 Sikagard®-720 EpoCem®
- 3 Construction joint Sika® Waterbar
- 4 Sika MonoTop®-412 NFG

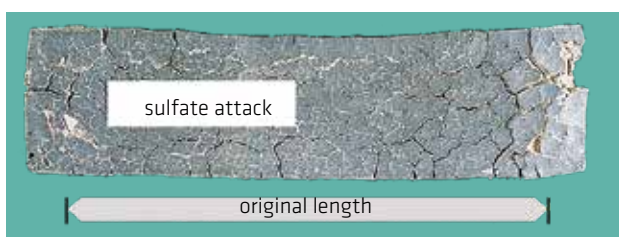
Sulfate driven attack is primarily caused by sulfates dissolved in water. By reacting with the hardened cement matrix, an increase in volume is induced, which damages the structure. (Picture: BetonSuisse, Merkblatt 01)

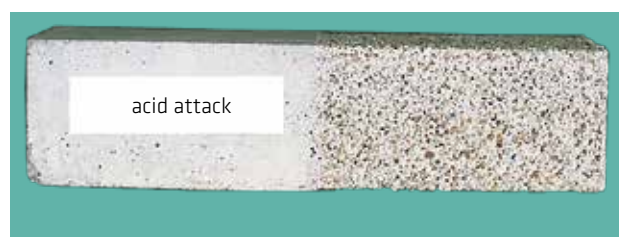
Acidic attacks which dissolve calcium compounds out of the hardened cement matrix can be caused by acids, exchangeable salts, vegetable and animal fats or oils. Degradation of the concrete usually occurs very slowly. (Picture: Beton-Suisse, Merkblatt 01)
